SOIL CLASSIFICATION REPORT

Site Details			
Address	9 Church Street, Bonnie Doon VIC 3720		
Client	Kate Holdsworth		
Owner/Developer	As Above		
Proposed Development	Additions & Alterations to Existing Dwelling		
Lot Plan	Lot 1 TP921139T	Property Zoning	General Residential Zone

Report Details			
Prepared By	Guy Taylor		
Site Investigation Date	29/01/2024	Report Date	12 February 2024
Reference No	TCE2404-2023	Revision	REV 1 – February 2024

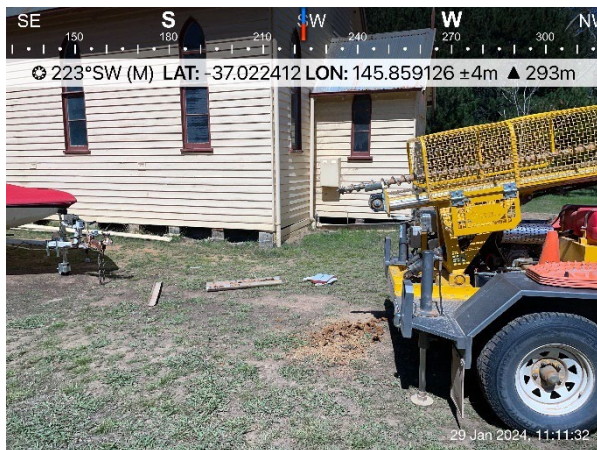
Photo 1: Proposed site of construction

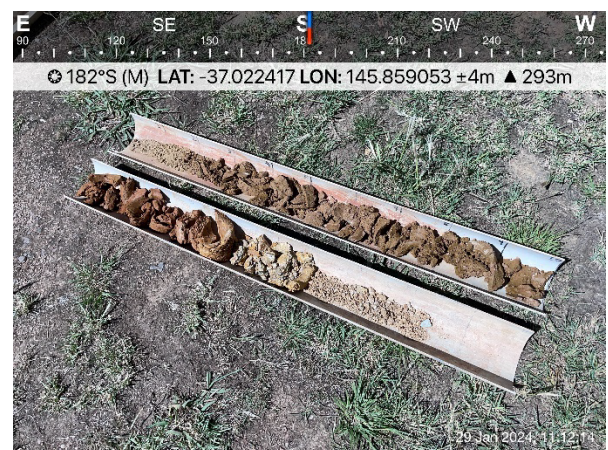
Photo 2: Soil profile at borehole
