Site Classification Report

Prepared for Leroy Palmer Consulting Engineers
30 June 2019

Proposed Residence
6 Lowe Court, Top Camp

Job No. ST20319

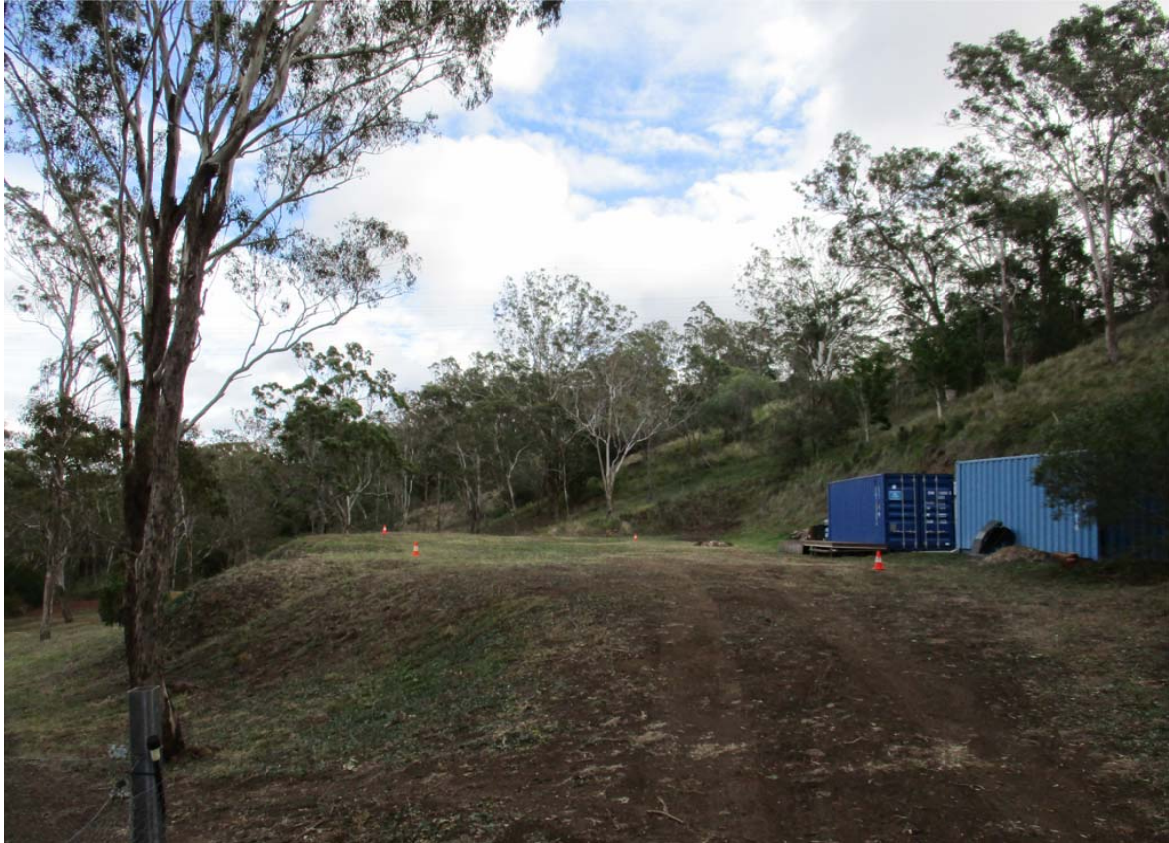
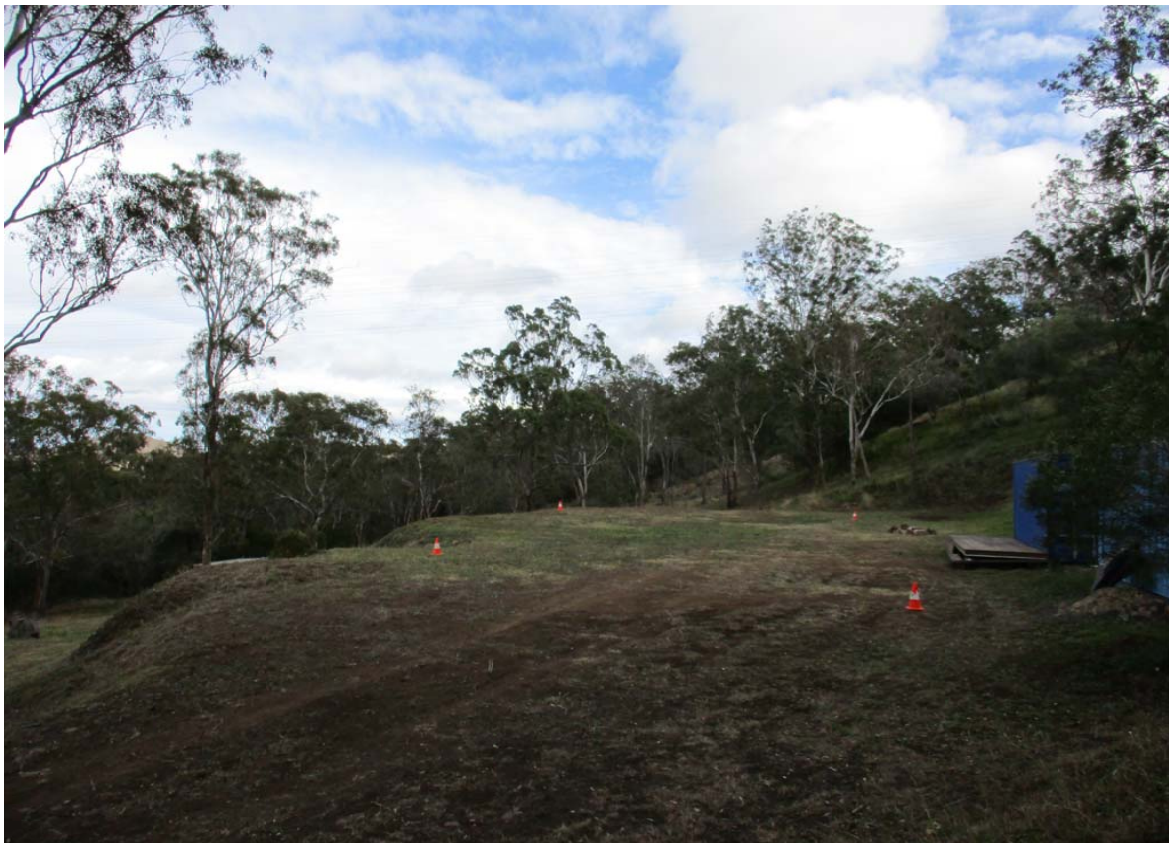
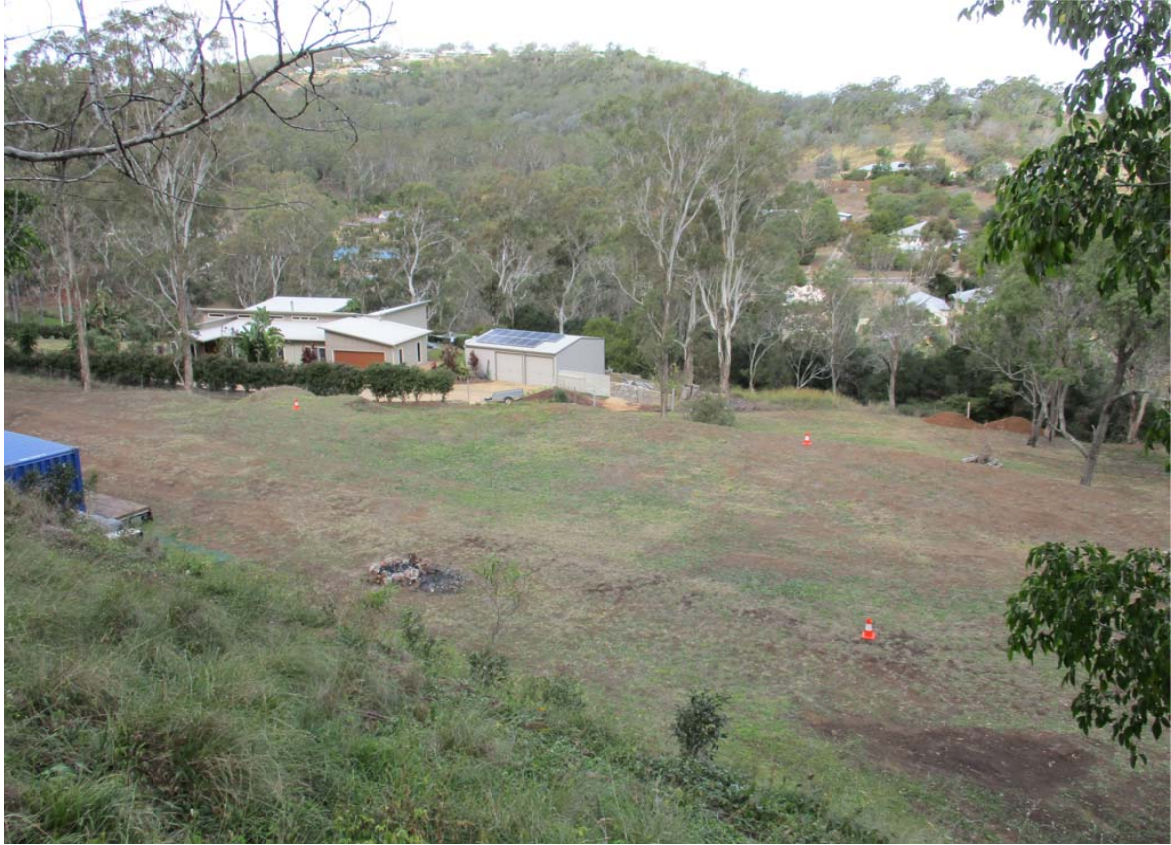
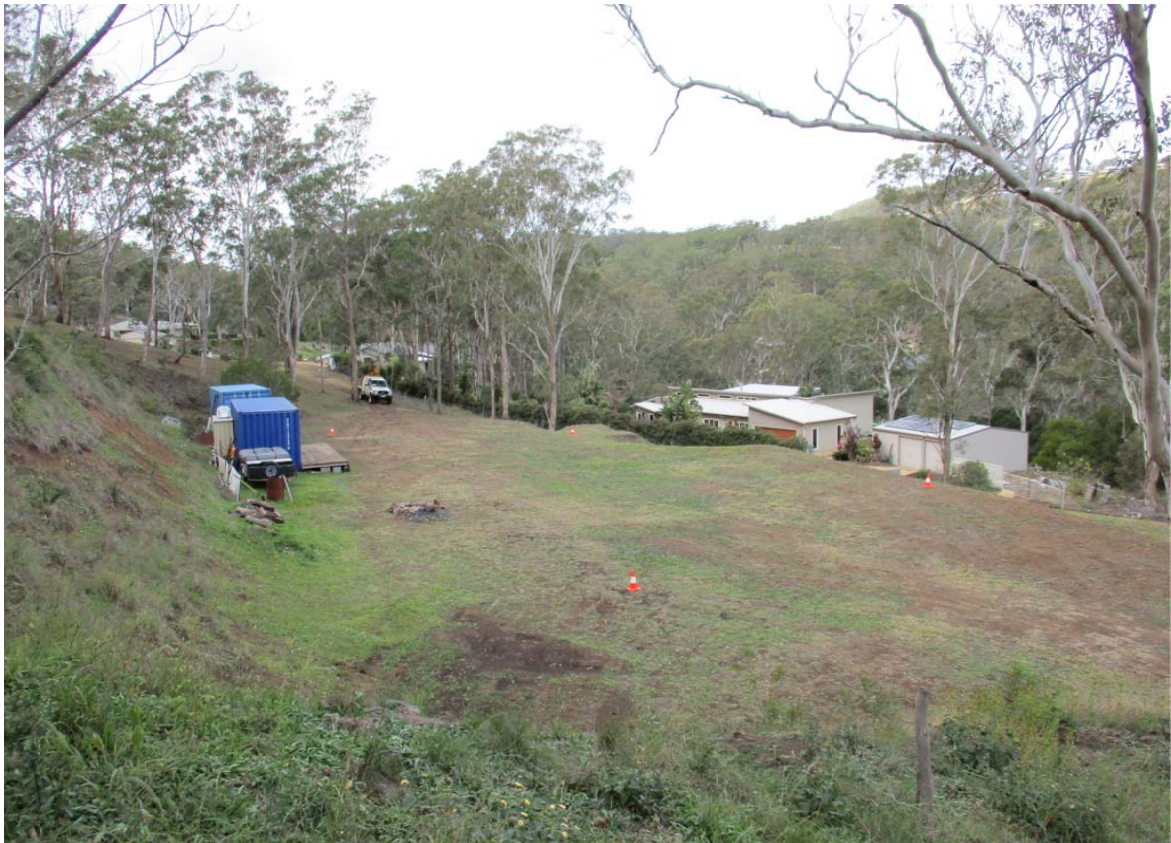
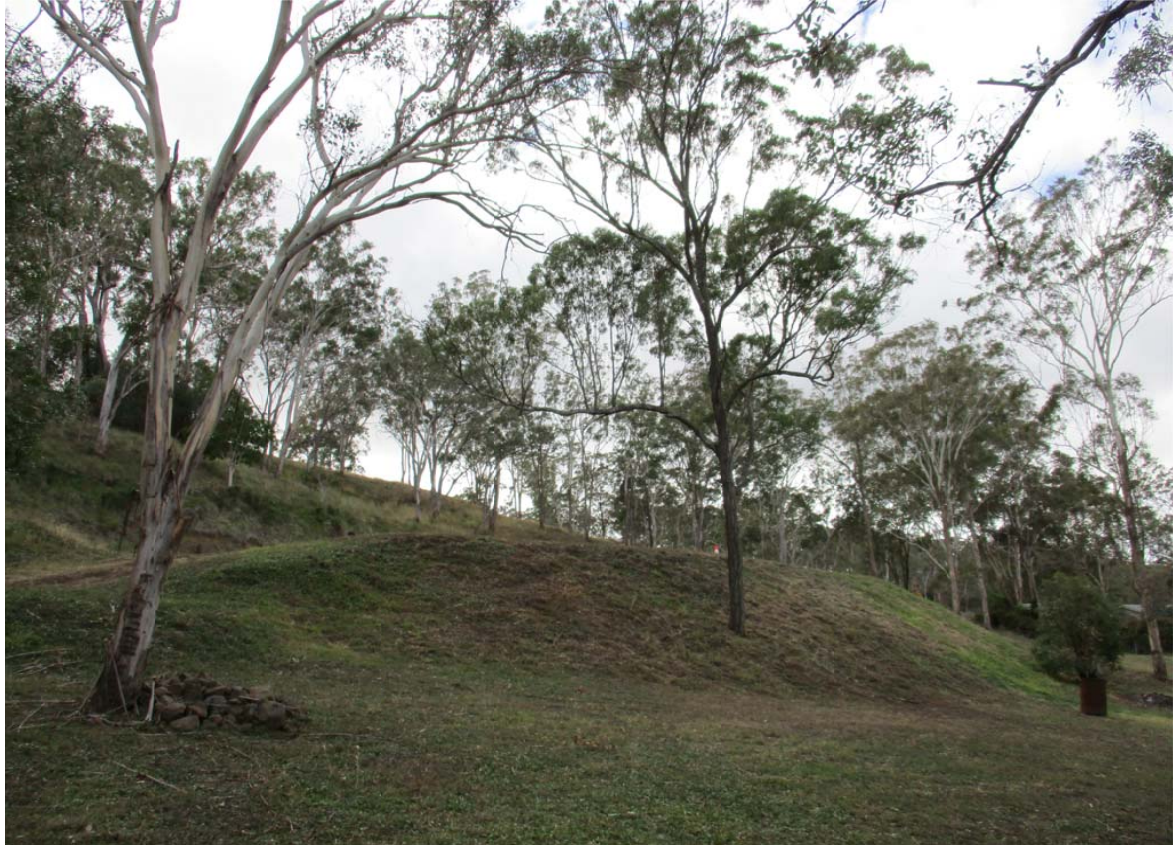
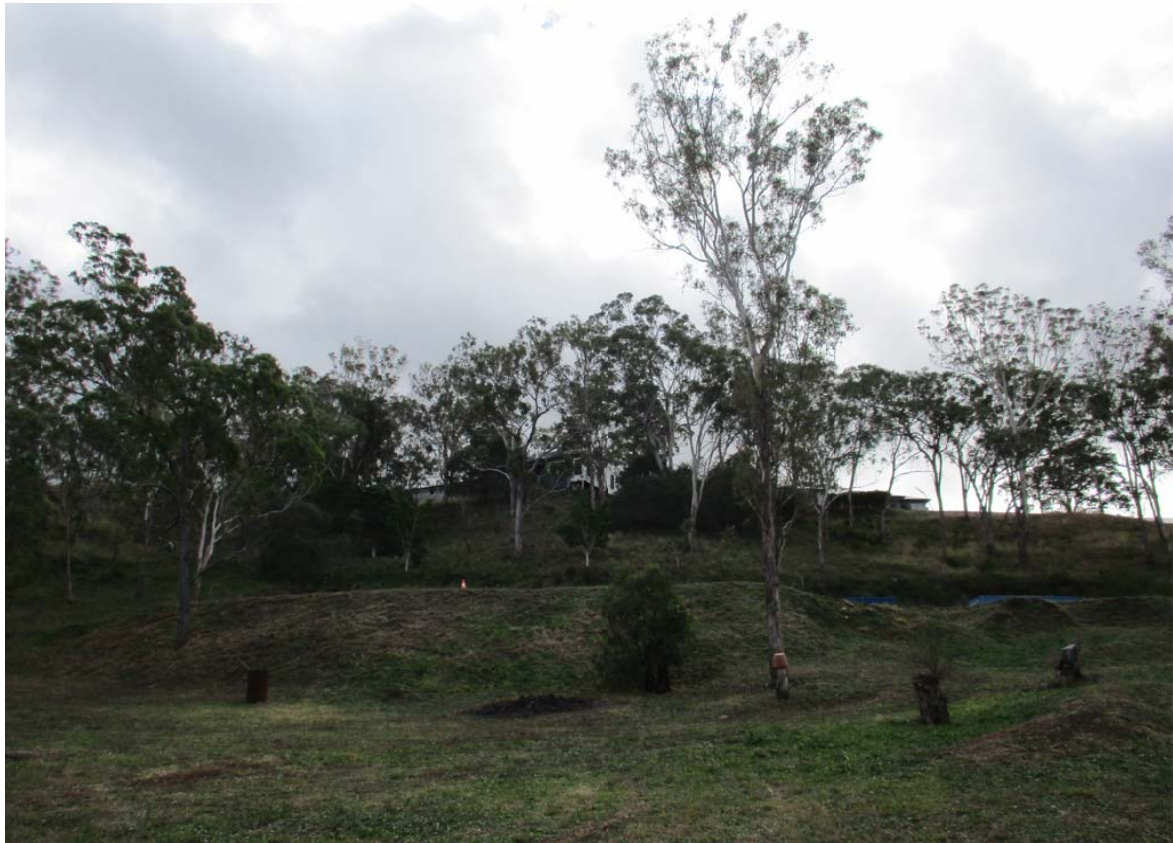
Numerous disturbed samples were collected from each borehole and hand classified on-site. The subsequent soil profiles with the appropriate Unified Soil Classification (USC) of each soil layer are shown on the borelogs in Appendix 1. Three disturbed samples were collected, sealed and returned to the laboratory for testing of moisture content on all samples and Linear Shrinkage characteristics on appropriate samples. No undisturbed samples were taken for Shrink Swell testing due to the nature of the material, however a detailed database of correlated results between Atterberg Limits and Shrink Swells has been used to estimate realistic I_{ss} values as per AS2870-2001 2.3.2 (ii).

After field assessment of the materials obtained on site, selected samples were returned to our laboratory for the determination of both moisture content and Linear Shrinkage of the soil. The results of this testing, as well as the results of any other relevant testing are shown on the borelogs in Appendix 1.

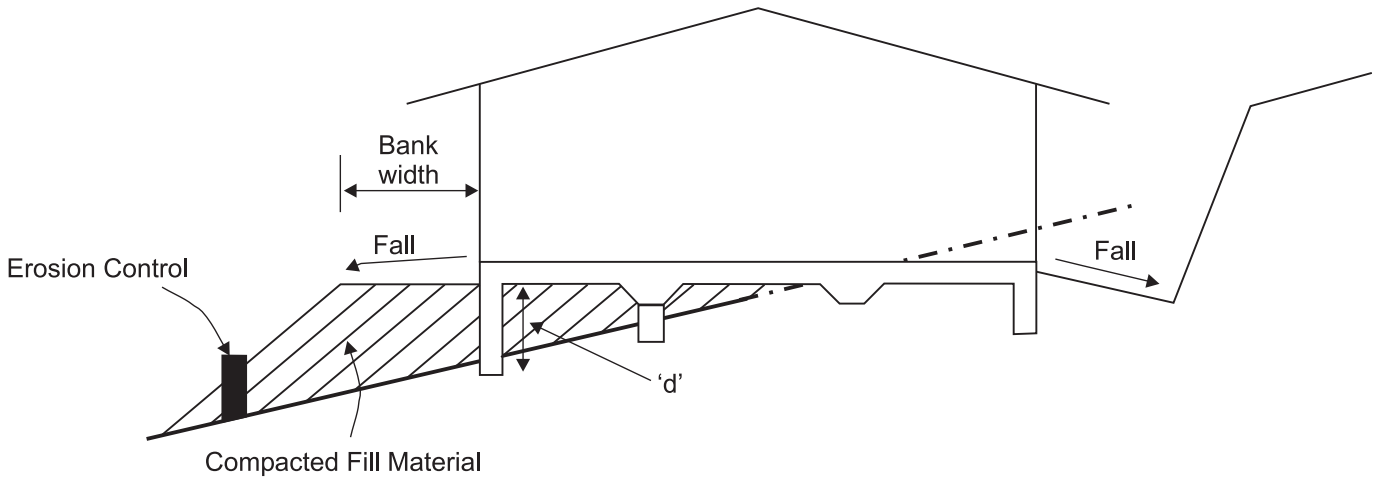
SITE EARTHWORKS

1. Bank Width - 1800mm or:
 - (a) 1.5d for Weathered Rock or well graded Granular fill:
 - (b) 2.0d for Clays or silty, sandy and gravelly Clays: Silts,
 - (c) 3.0d for sands and soft Clays.
2. Where the specified Bank Width above cannot be achieved, an Engineer should be consulted for a Retaining Wall &/or Pier Design.
3. All organic matter should be removed from the intended building site prior to construction of the foundations.
4. If any trees are removed to be removed, the grubholes shall be backfilled and compacted according to Note 5.
5. Any material used as fill underneath the intended building shall be built up in layers of 150mm moistened and compacted with suitable compaction equipment to 95% Standard Compaction in accordance with AS 3790.

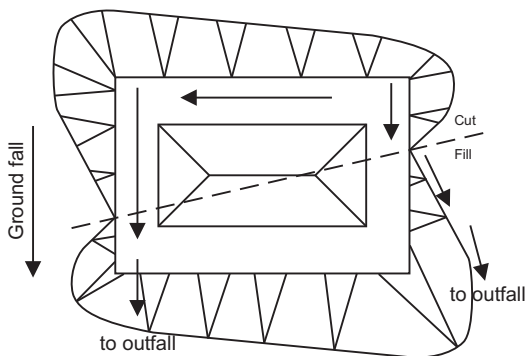
TYPICAL DRAINAGE LAYOUT FOR CUT/FILL SITES

1. It is extremely important to maintain good drainage throughout constructions of any building
2. Fall away from the building shall be 50mm for the first metre so water does not pond against or near the building
3. All water run-off shall be channeled away from the building at all times pre & post construction
4. For flat sites, an Engineer should be consulted to ensure that the finished height of the building allows proper drainage away from the building
5. Drainage must not direct water to adjacent blocks in a concentrated form
